Bankside erosion at the River Spey near the Old Bridge Inn, Aviemore, had been accelerating in recent years. Without intervention there was a high chance that the whole section would collapse in due course, potentially impacting on the nearby road. The standard approach to protecting river banks is often hard engineering solutions that use rock or concrete. However, wherever possible this is now being discouraged in favour of more natural, sustainable, environmentally friendly and aesthetically pleasing techniques that are based on natural materials such as large root wads or live trees.

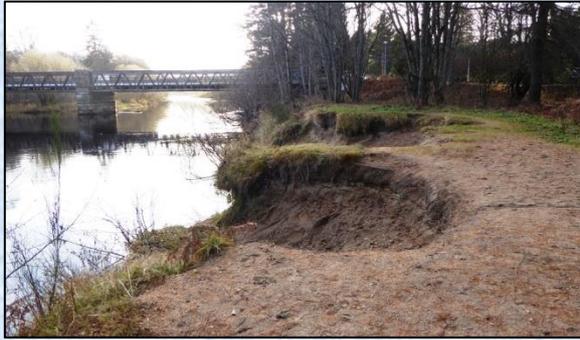
*Eroding bank before works*

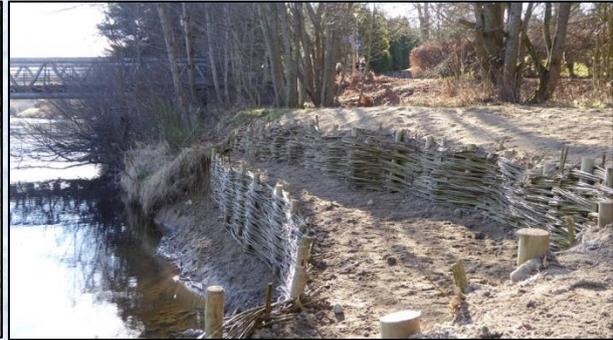
*Post repair*

The repair at Aviemore has been undertaken using willow spiling, a technique whereby live willows are woven into a support structure of willow posts that reinforces the bank and in time becomes a “living wall”. To date very little willow spiling has been undertaken in the catchment, the only local example being a short single tiered section along the Allt Ban (a spatey upland burn) at Glenmore. The Aviemore site, alongside a fast flowing section of a major Highland river has provided an opportunity to undertake a more complex repair using a two tiered system.

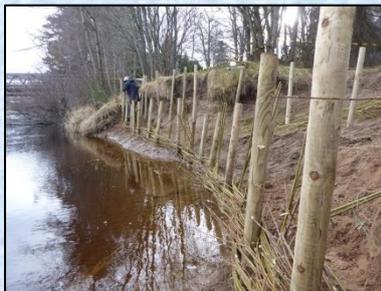
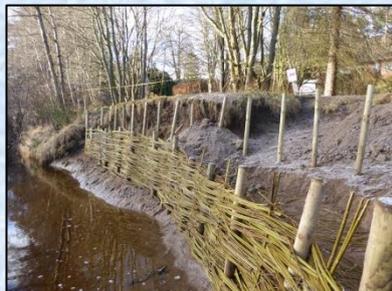
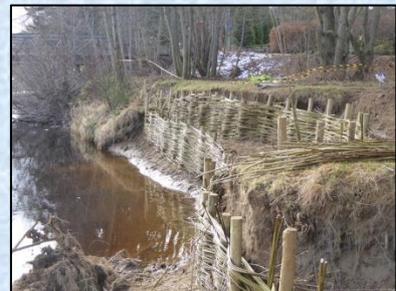
*Repair works in progress.*
