VAKI Fish Counter Installed on the River Dullan

SPEY FISHERY BOARD RESEARCH OFFICE

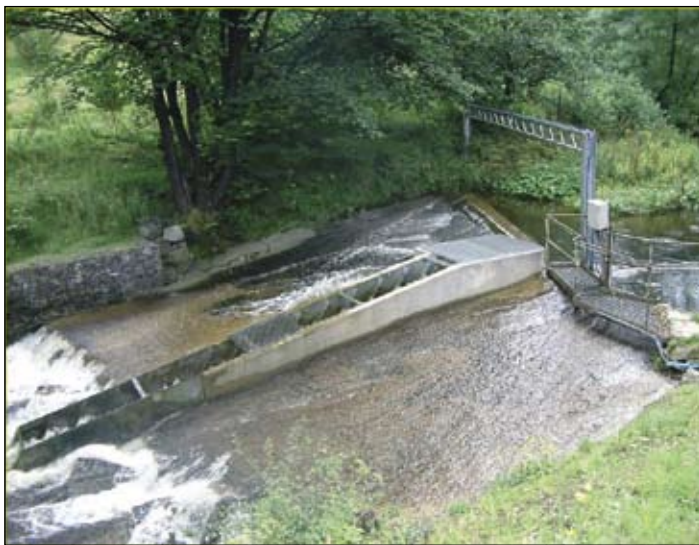
Mortlach weir with Denil fish pass completed. The VAKI counter is housed in the upper chamber of the fish pass.

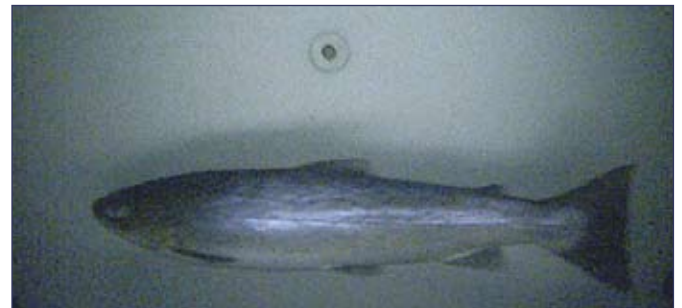
In clear water flow conditions upstream fish, like this sea trout, can be readily identified.

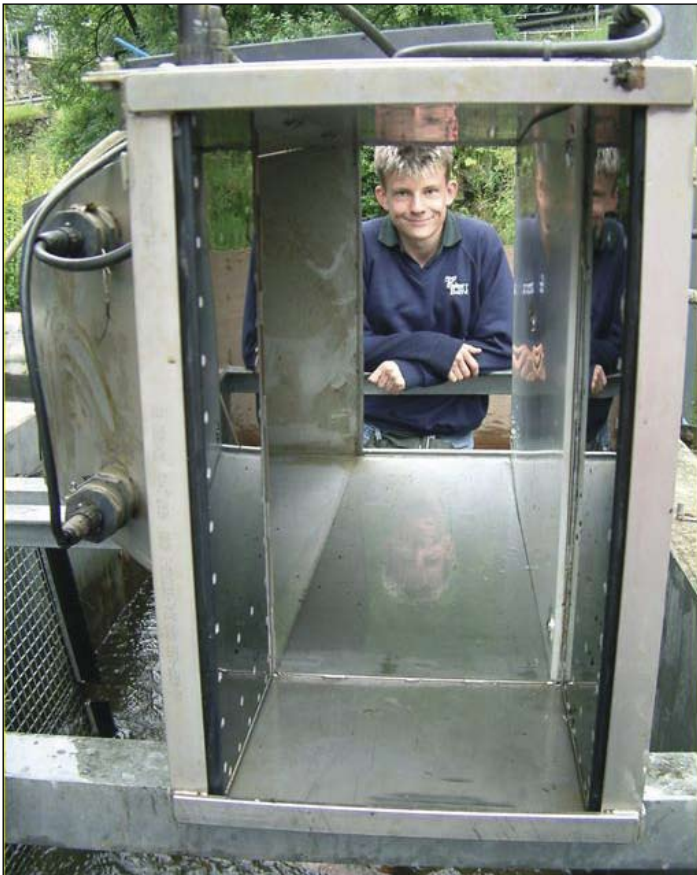
Summer student, Alan Wickham, views the VAKI counter before installation.

Ascending fish swim through two infra red scanners (the black panels at this end of the device). An infrared image is then produced and stored in the operating computer. When a fish moves up through the scanner the camera and lights are triggered and upto five photographic images are collected as it swims through

the chamber. The camera can also be adjusted to collect video footage of the fish passing through. Downstream fish are also detected by the infrared scanners but so is debris. Currently no photographic images are available for downstream passage. For more information on VAKI counters go to **www.vaki.is**.

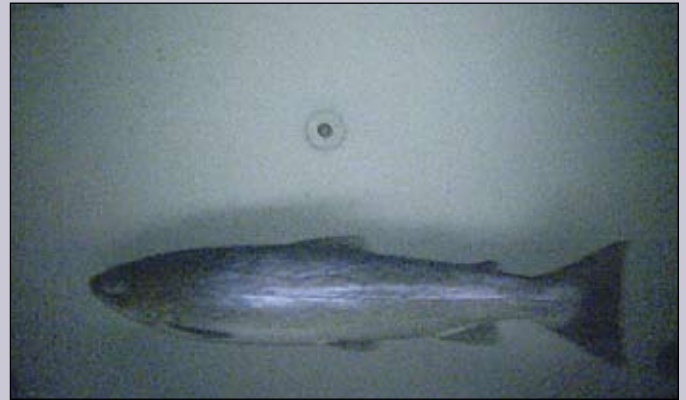
In clear water flow conditions upstream fish, like this sea trout, can be readily identified.

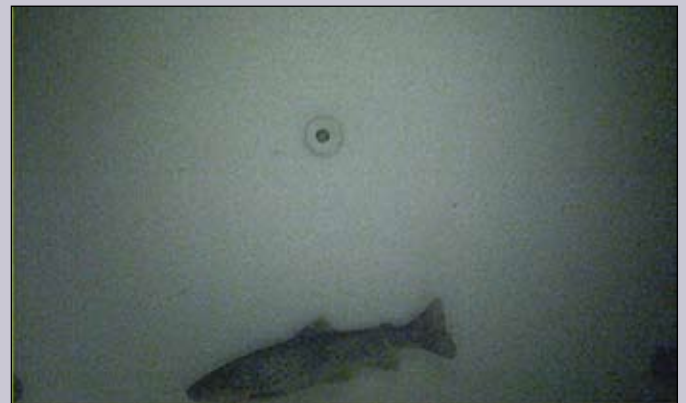
Upstream migrating Brown Trout (approx 25cm).
